National Transportation Safety Board

ERA22FA105

AIRWORTHINESS

Group Chair's Factual Report

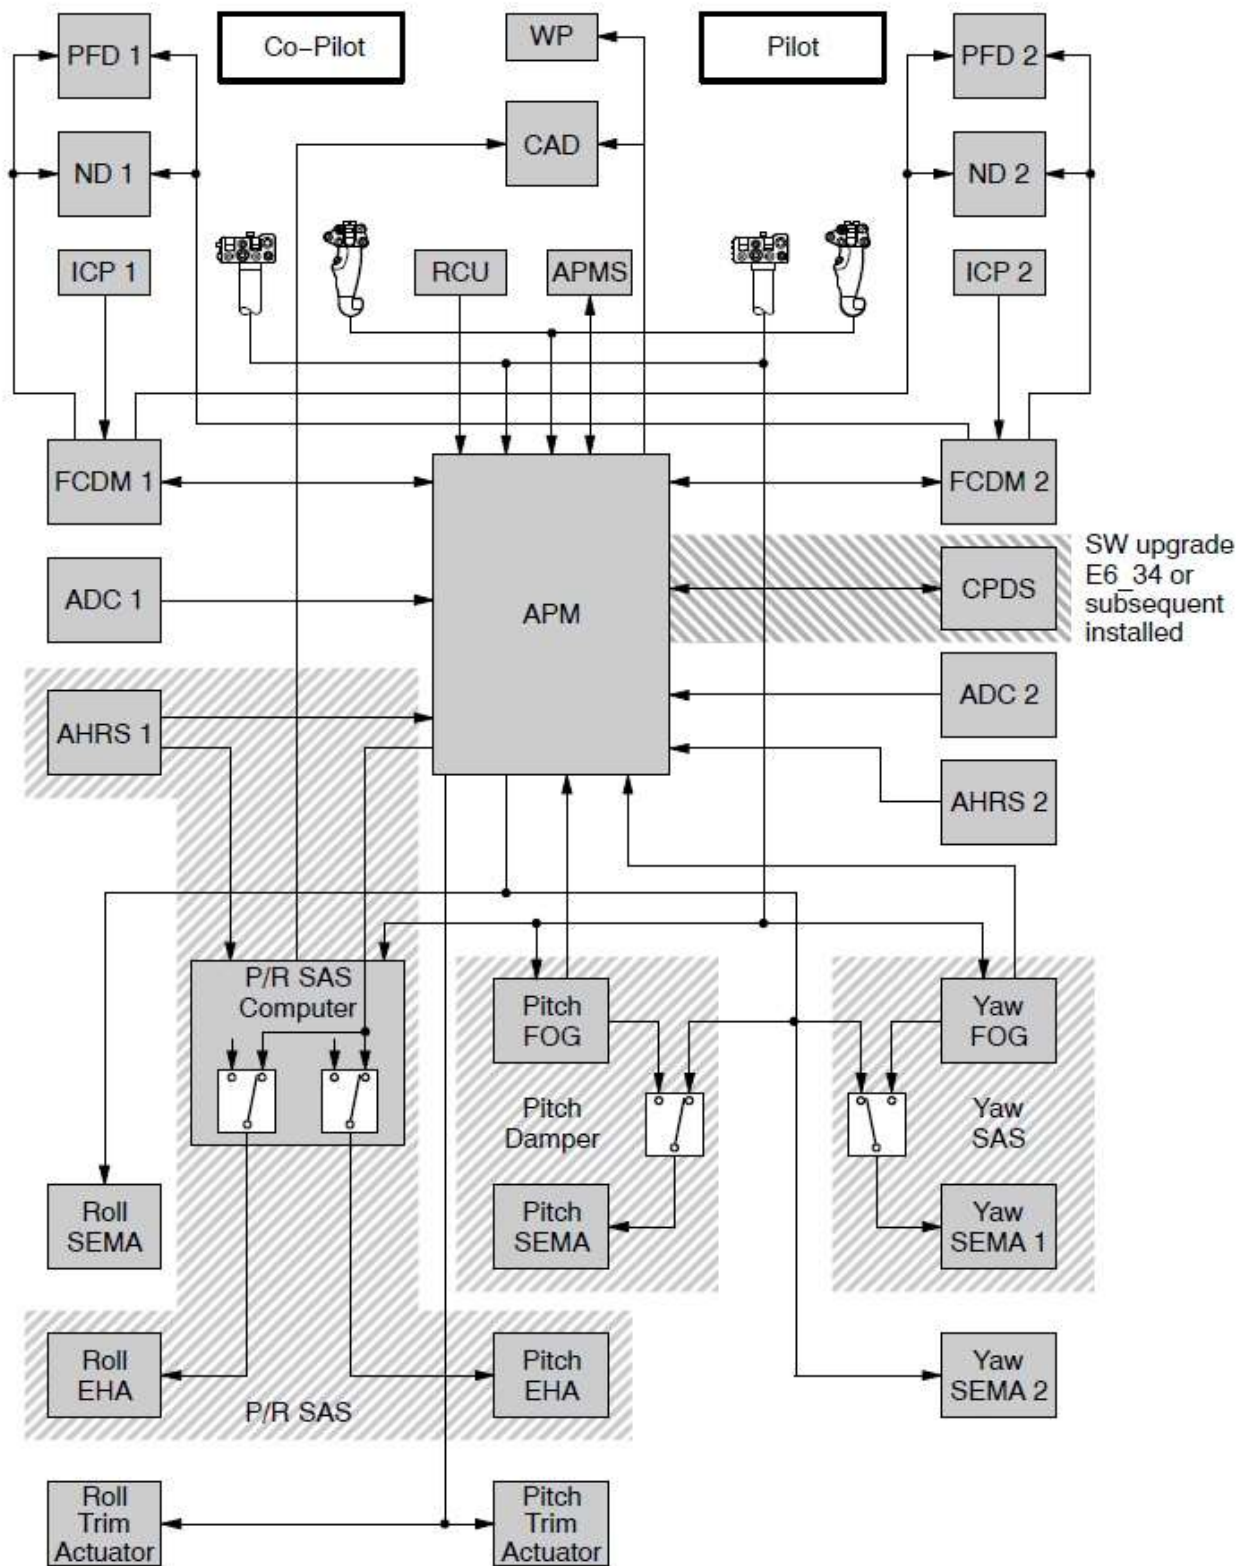
The accident helicopter was equipped an AFCS composed of SAS and autopilot systems that can control helicopter pitch, roll, and yaw through various actuators (**Figure 4**). The AFCS does not have any control authority for the collective control system. A pitch smart electromechanical actuator (SEMA) and a roll SEMA are located between the upper guidance unit and the MRAs. A pitch electrohydraulic actuator (EHA) and roll EHA are integral to the pitch and roll MRAs, respectively. The pitch and roll SEMAs are installed in series to the pitch and roll EHAs, respectively. Two yaw SEMAs are installed in series forward of the TRA. Additional components integral to the AFCS include the autopilot module (APM), AHRS, air data computer (ADC), yaw and collective linear variable differential transducers (LVDT), a pitch FOG, and a yaw FOG, and the pitch and roll SAS computer.

Figure 4. A diagram of the AFCS on the EC135-series helicopter. (Image courtesy of Airbus)

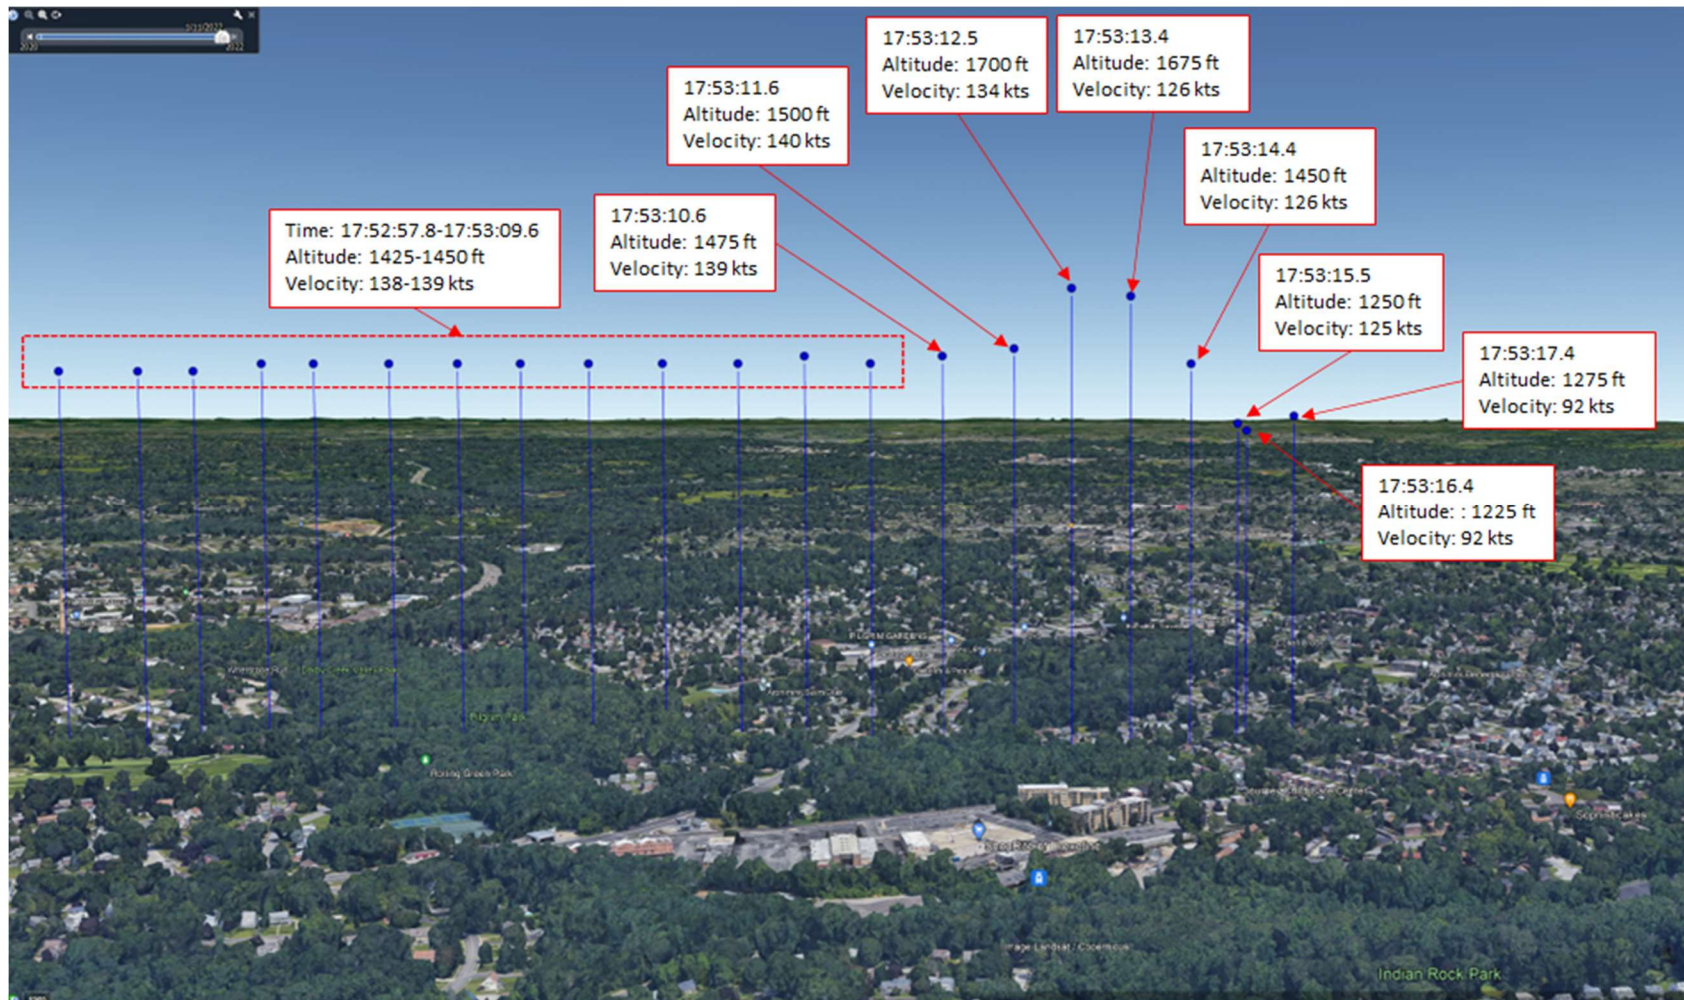
Figure A-1. A depiction of the flight leading up to the altitude excursion based on the ADS-B data.⁴⁰
